# North Tower Repairs

John Vasa and Case Vasa (from Weston) have been working on North tower of the Church for past two month. They first repaired the turrets on the South side that had been damaged and one of them in storage for several years. They agreed to restore the louvers on the N side of the N tower, by scaping, priming, repainting and covering with plexiglass (to match). They found a lot of leakage in flashing, joints and flat surfaces, that led to deteriorated wood, crumbling mortar, and leaky flashing that needed repair on the four sides of tower. They will do one corner at time and as of August 18, will begin on the third corner. These photos show some of the damage and restoration work.

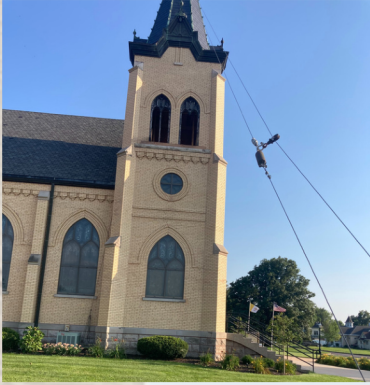
Shows the North Tower, the removed louvers and openings that need repair. The winch cable attached to the truck allows Vasa to raise lumber, tools and materials to their workspace through the windows.

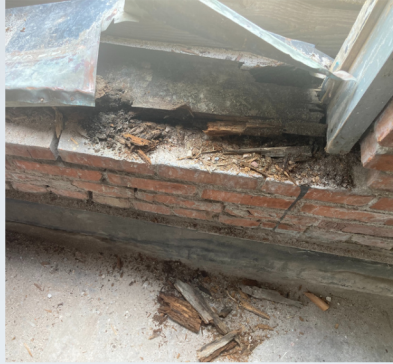
Shows the crumbling windowsill and faulty mortar under the open window space.

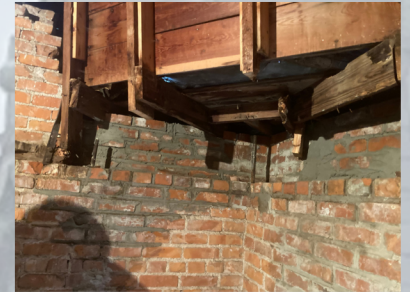
Shows the new mortar and reinstalled bricks (5 or more layers) to support the corner. Also, the cut off vertical support beams that line the interior of the steeple.

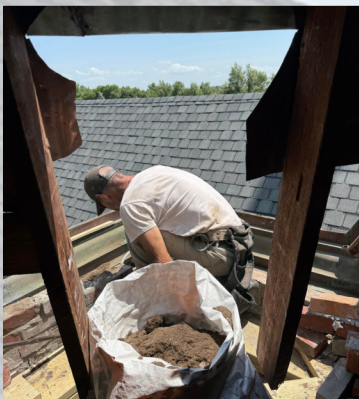
Shows John doing brick repair in before the new flooring and decking goes in where Case is standing in the small picture.

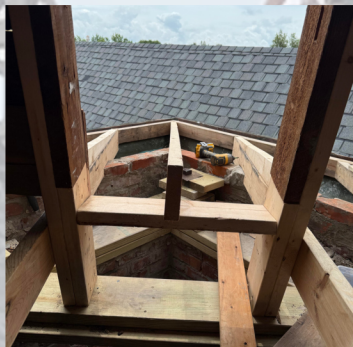
Shows the new horizontal and vertical wood structure that Case is standing on. You can see the pitch to drain the water away from the tower.

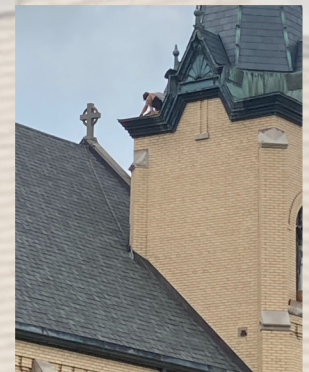
Shows Case working on the first corner.

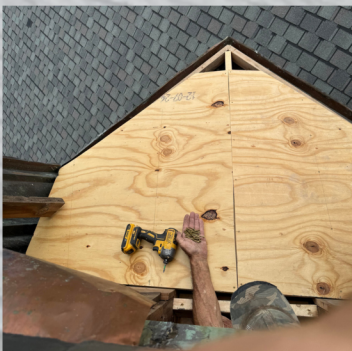
Shows John with drill and screws with new plywood decking.

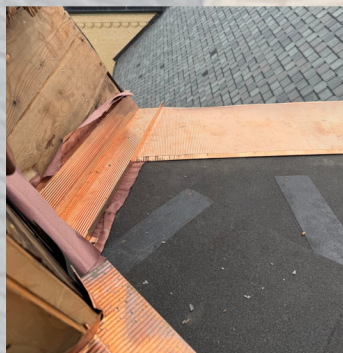
Shows the new wood installed, tarpaper and new copper flashing and paper backing to help with drainage off the deck.

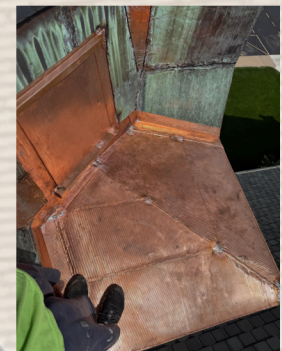
Copper and access hatch soldered and completed.
